## Soil and Site Evaluation Discussion

This soil evaluation is for a new STS (sewage treatment system) for a new 2 or 3 bedroom home (example that may change) on your property. On the attached sketch map, we have approximately located, a possible new home site and proposed both the primary and secondary filter field areas for waste water disposal areas. The proposed home site and waste water disposal area for a sewage treatment system are tentative, because the new owners may want the home in another location. The proposed filter field area is located in natural soils and the disturbed soils associated with coal mining are located further upslope or north of the proposed filter field areas. The proposed filter field areas are very different, as we will discuss this further in this report. The new home location was selected at this location to get gravity flow to the proposed filter field areas downslope.

# Sketch Map for Country Tyme Property (Tract #1)

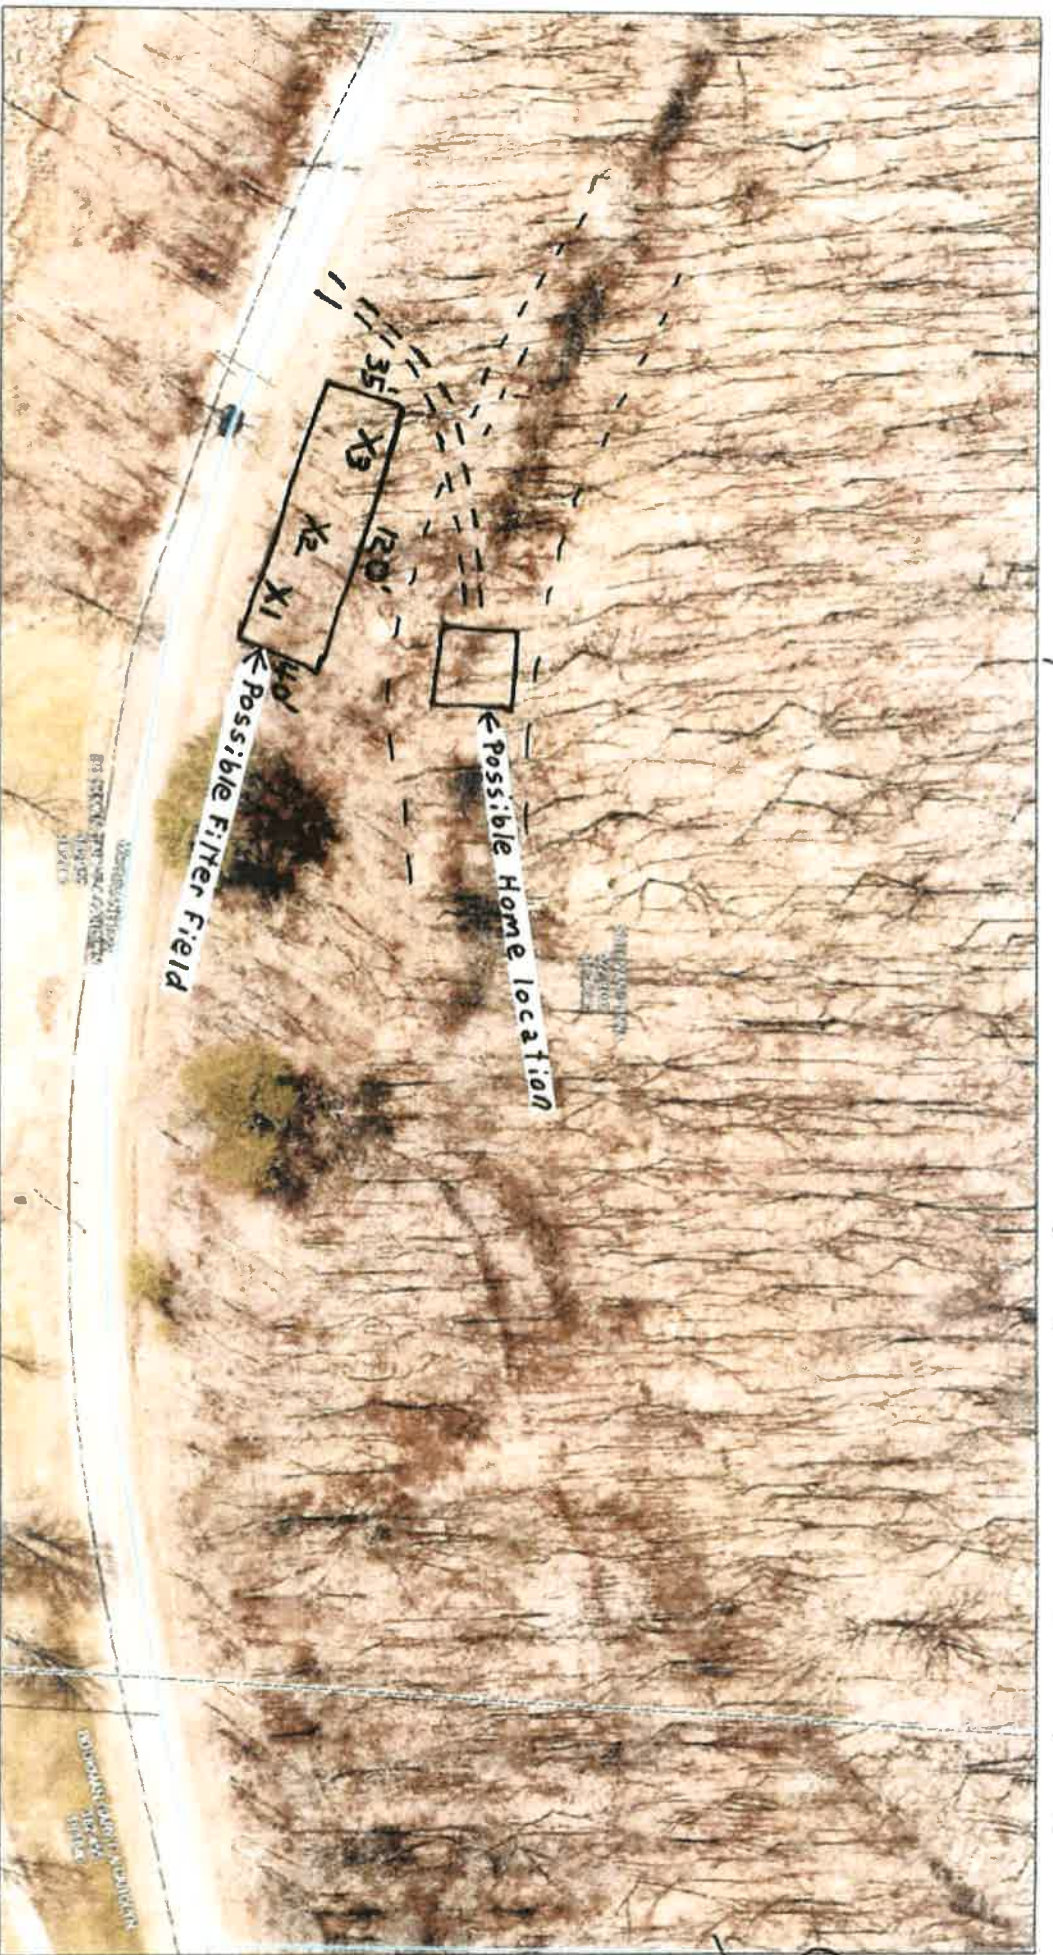
# Sketch Map for Countrytyme Property (Tract #5)

These are all Approximate Locations (not to Scale)

We have shown the location of the proposed septic or aeration tank absorption field area on the sketch map. We have marked the proposed filter field area with pink wire flags and maybe a pink ribbon on the taller vegetation, if present at the approximated boundary corners. The soil description sites are marked with orange wire flags and the number of the description is marked on the flag. The approximate dominion, of the proposed filter field area, is marked on the sketch map. The proposed filter field area is just an indication of the area that can be used, the installer or the health department will determine where the filter lines will be located. The filter field lines would need to be located level on the contour around the slope. These soil descriptions were taken at random to show the soil properties at different areas within the proposed filter field area and the sketch map is not to scale. We gave a house site location (example that may change with new owner) on the sketch map to give you a possible reference point, for this report. We have attached a design worksheet using the #1 soil description in the proposed filter field to give you an indication of what we seen on site.
