Lot 3

## Site and Soil Evaluation for Sewage Treatment and Dispersal

| Property Address/Location: | 0 FLINT RIDGE RD.<br>NEWARK, OH 43055 | Position on Landform: | HILL/ SLOPE | |

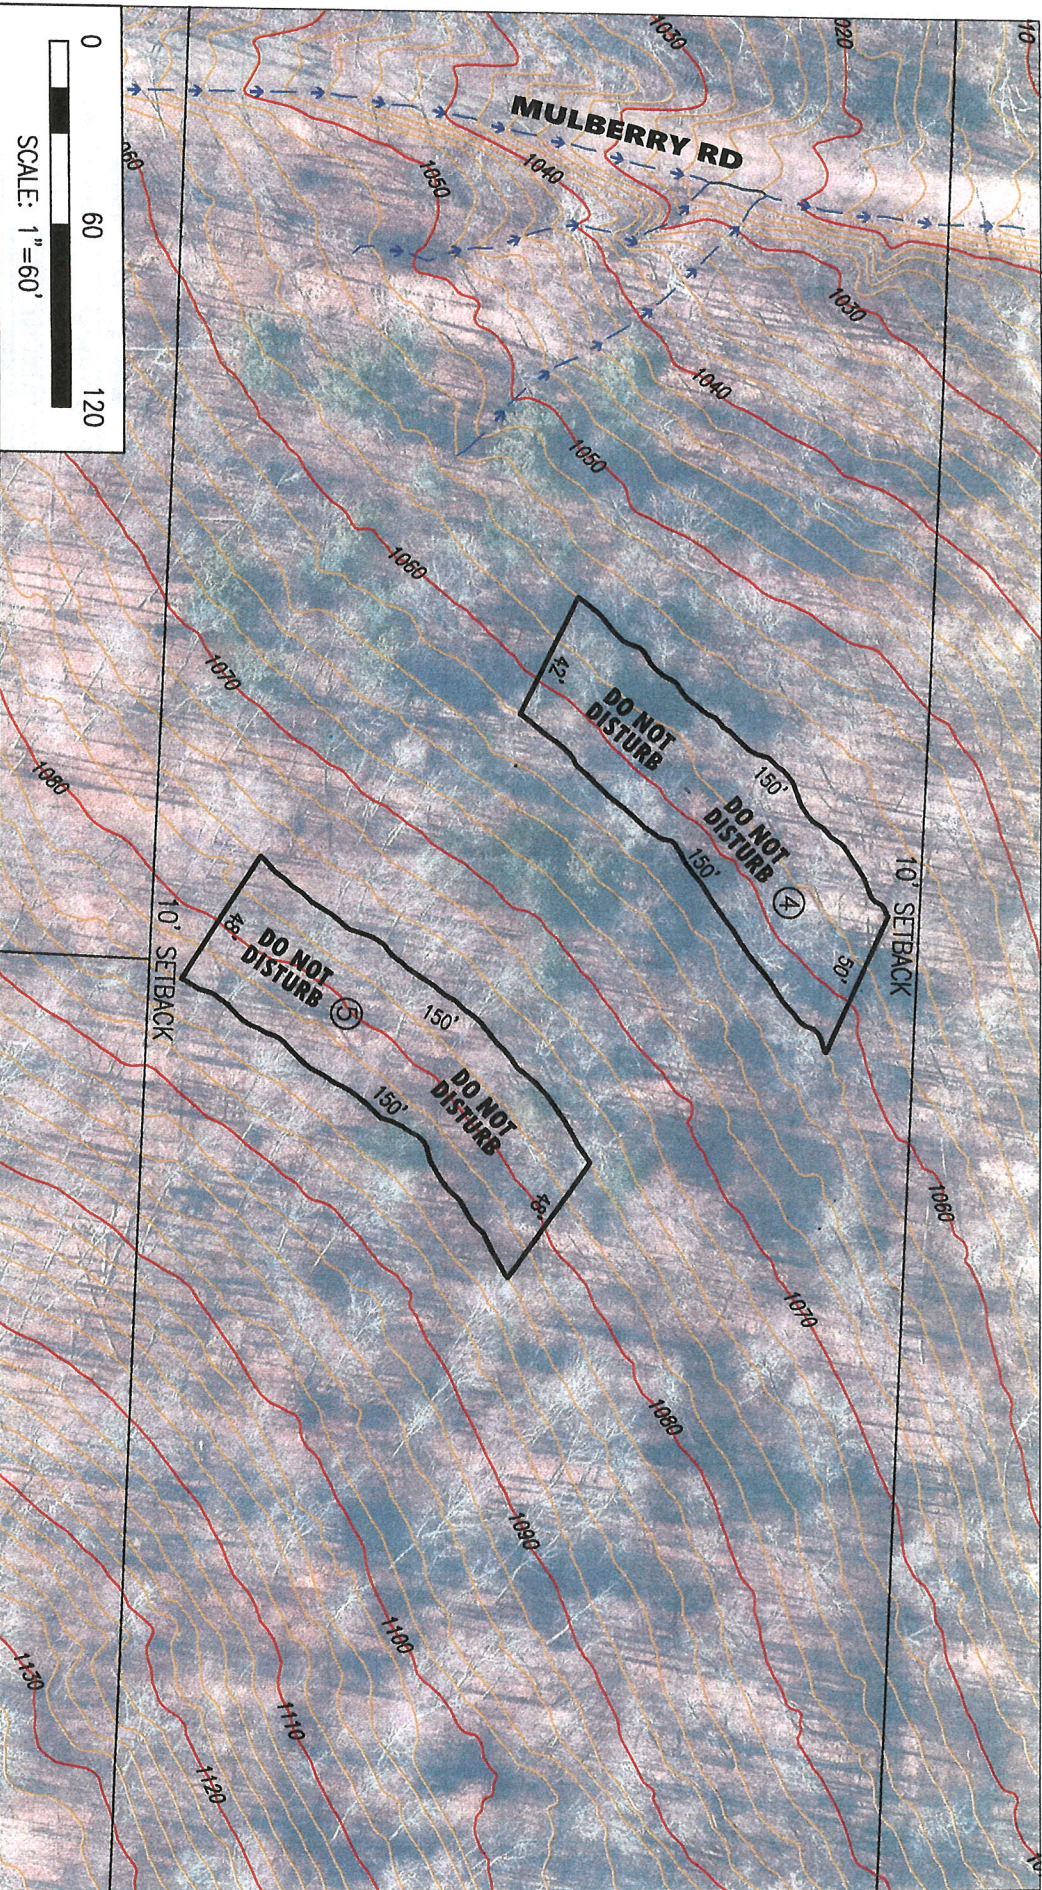
NOTE: SITE PLAN PREPARED USING GARMIN GPS, LICKING CO., AND OGRIP GIS DATA. DATA SHOWN IS ASSUMED CORRECT, BUT HAS NOT BEEN SURVEYED. STRUCTURE LOCATION IS NOT FINAL. DRIVEWAY/STRUCTURE LOCATION SHOULD BE LOCATED ON THE LOT TO ALLOW FOR A LEACH SYSTEM THAT MEETS, OR EXCEEDS, THE MINIMUM LENGTH OF TRENCH REQUIRED.

NOTE: DO NOT DISTURB DESIGNATED LEACH FIELD AREAS UNTIL INSTALLATION
